# CERTIFICATION REPORT

## Alliance for Water Stewardship (AWS)

Site: **Nanya Technology Fab 3A & 3A-N - Taipei**

Audited Service(s): AWS Standard v2.0 (2019)

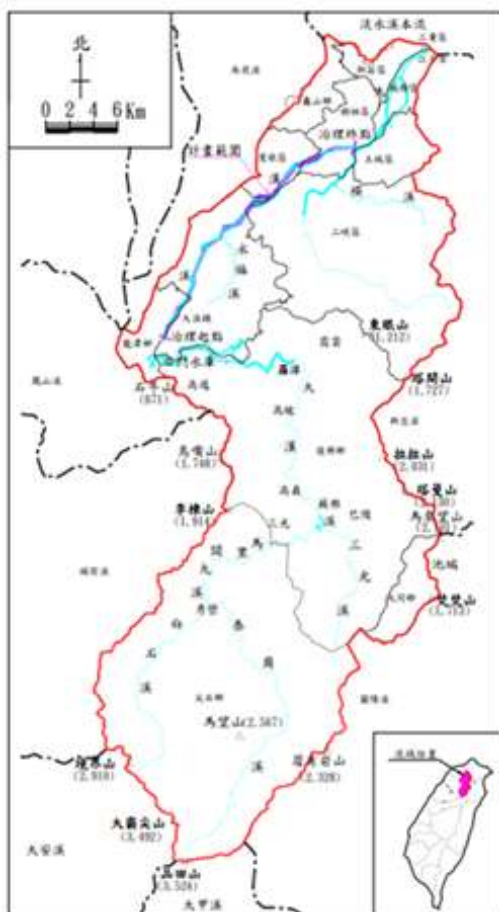
catchment layout.png

Dahan Creek is located in the northern part of Taiwan and is one of the three major tributaries of the Tamsui River system. It originates from Pintian Mountain in the Snow Mountain Range, with a main flow of 135 kilometers and a flow area of approximately 1163 square kilometers. The section from Dahan Creek to Xiuluan Village is called Malikuoman Creek. After merging with Baishi Creek at Xiuluan, Taigang Creek turns eastward for one kilometer, then merges with Sanguang Creek and turns northward. It passes through Gaoyi Village and then turns westward near the upstream of Luofu (La Hao), and finally turns eastward at Shimen Dam site. The section from Xiyuan to Shimen Dam Site has a turbulent flow, narrow valley, and multiple cliffs on both banks. Below Shimen, the mountain terrain converges, and the flow rate slows down, eventually merging into the Danshui River at Jiangzicui. The Dahan River has a flow area of 759 square kilometers above Shimen, and a Shimen Dam has been built here. The main tributaries below are Yongfu River and Three Gorges River. The area from Dahan Creek to above Shimen is about 759 square kilometers, belonging to the mountainous area. The Shimen Reservoir was built here, and the middle reaches are vast and fertile river terraces with abundant agricultural products. The lower reaches enter the alluvial plain, with dense population on both banks of the river and developed industrial and commercial industries, which have been incorporated into the Greater Taipei metropolitan area.

Taoyuan Canal, is one of the important water conservancy projects in Taiwan, with the construction of a main line and 12 branch lines connecting Pi Tang. The Taoyuan Canal takes water from the Shimen area upstream of the Dahan River and irrigates 22000 hectares of farmland on the Taoyuan Plateau through a 20 kilometer waterway and a 25 kilometer main line. The Taoyuan Canal System has 132 river weirs and 231 water storage tanks, with a total area of 2218 hectares and a total storage capacity of 66 million cubic meters, as well as 846.5 kilometer water supply road.

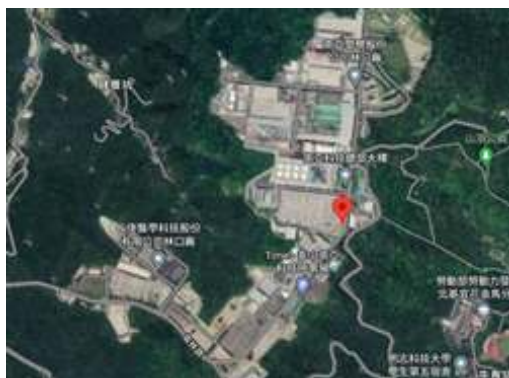
layout map.png

Nanya Technology Fab 3A & 3A-N is located at No. 98&115 Nanlin Road, Taishan District, New Taipei City 243, Taiwan. The site covering the area of 130 thousand square meter, with over 3500 employees.

The site uses municipal water supplied by Nanlingqing Water Plant, and the ultimate water resource is Taoyuan River, one of the tributaries of Dahan River.

The wastewater is treated by onsite WWTP, and then discharged into Qiancuokeng Creek, and finally goes to Dahan River.

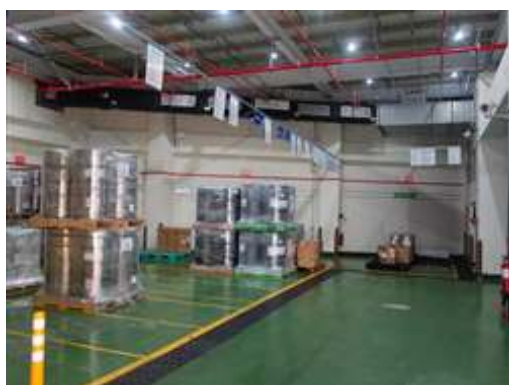
chemical warehouse.jpg

| Comment | The potential sources of pollution has identified and mapped, including the chemical storage area (such as TMAH, photoresist, hydrochloric acid), diesel tanks, waste storage area and laboratories. | |

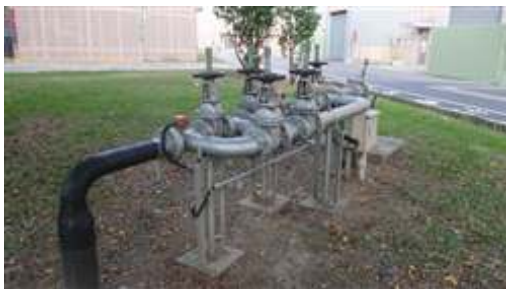
well.jpg

| Comment | The groundwater wells are only used by the site. As per site tour and interview, no onsite IWRA is in the site. | |
